SCS DAM PA-452

NDI NO. PA-00100

WAYNE COUNTY, PENNSYLVANIA

PHASE I INSPECTION REPORT
NATIONAL DAM INSPECTION PROGRAM

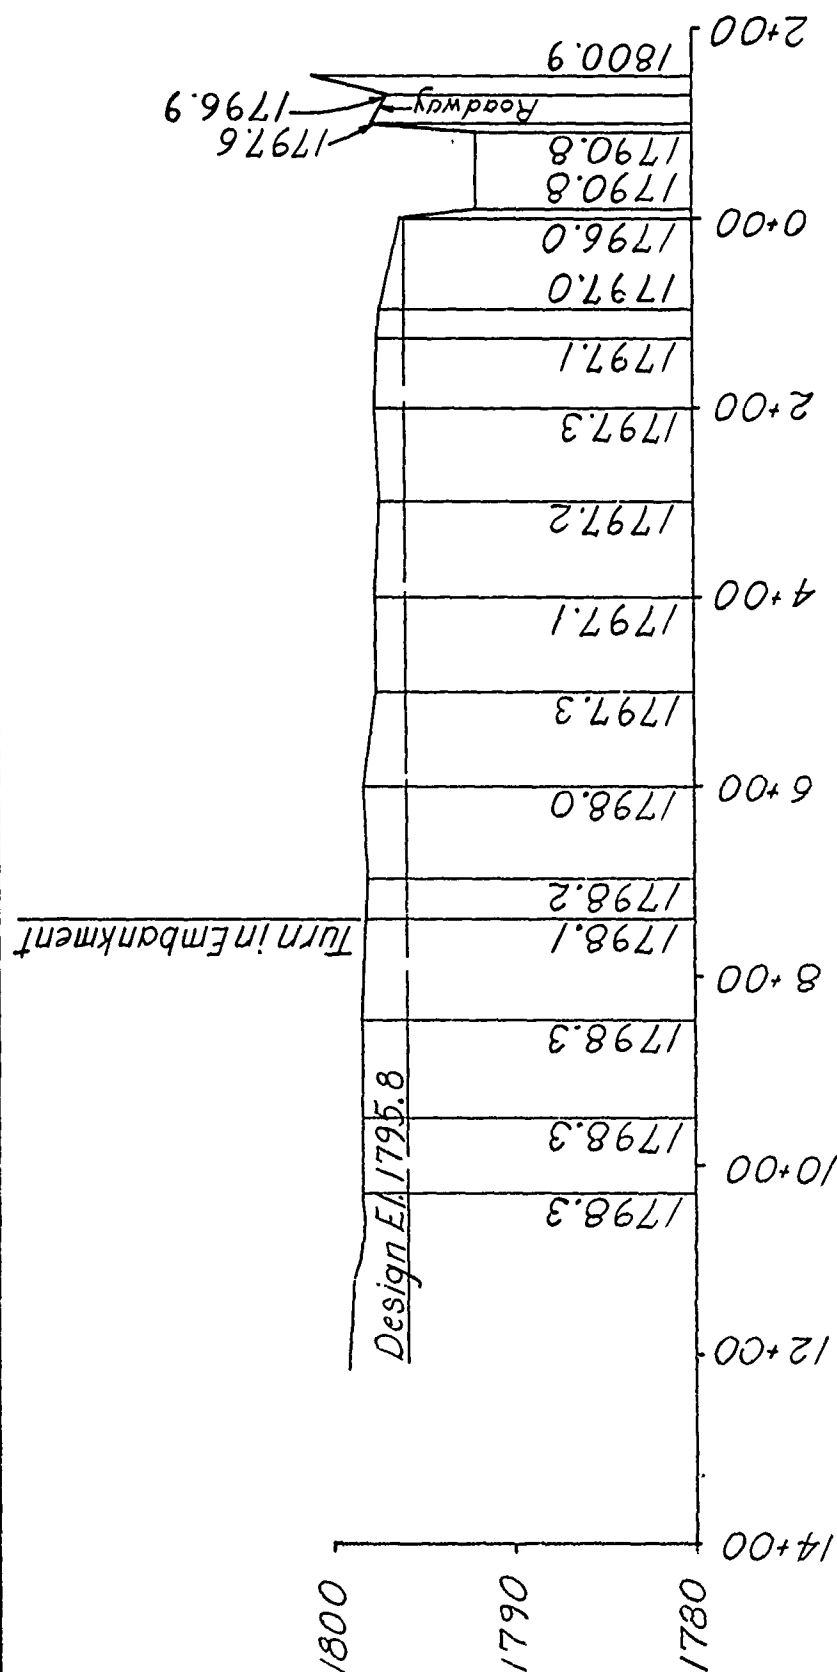
SCS DAM PA.452
PA.-00100
INSPECTION SURVEY
PLATE A-II

D. ALIGNMENT OF CREST: HORIZONTAL: VERTICAL:	Horizontal - straight alignment with 90° bend. Vertical - refer to profile Appendix A, Plate A-II.
E. RIPRAP FAILURES	No riprap.
